MULTI-STAGE REMEDIATION REMOVES CHLORINATED SOLVENTS FROM FORMER DRY CLEANING FACILITY

By Grant Walsom and Michael Schriver

XCG Consulting Limited was retained by the owners of a commercial real estate property to remediate impacts in soil and groundwater related to the property's former use as a dry cleaning facility. The client chose active remediation to meet provincial Generic Site Condition Standards.

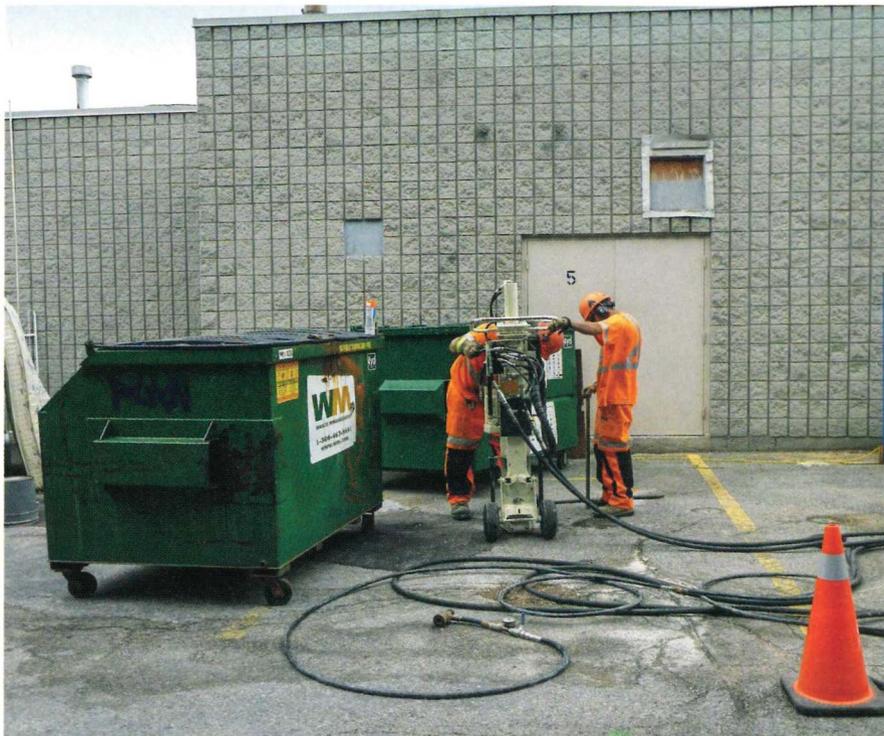
Direct injection of solutions of ISCO reagents to the subsurface using drilling equipment and low pressure pumping system.

Following the initiation of groundwater extraction events, XCG implemented a program of in situ chemical oxidation (ISCO) through the advancement of temporary subsurface injection points at interior locations through the concrete floor slab of the building, and at exterior locations through the asphalt surface. Solutions of oxidizing compounds (sodium persulphate and potassium permanganate) were injected at low pressure through the temporary injection

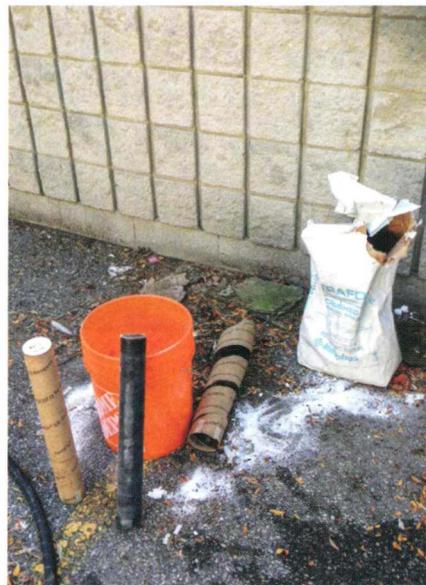
View of the RemOx@SR Plus ISCO reagent cylinders.

Within the saturated zone of each borehole, RemOx®SR Plus ISCO reagent cylinders and dispersant were applied to facilitate the slow release of oxidizing compounds (potassium permanganate and sodium persulphate) to the shallow groundwater in the remaining impacted areas. The reagent cylinders consisted of dry crystals of the oxidizing compounds, encased in degradable paraffin wax. As groundwater dissolves the wax, the oxidizing compounds are released and disperse slowly into the groundwater.
